Non-Osmotically-Induced Blistering Phenomena on Metal

Last month, we discussed one of the most common types of blistering of paint films on metal—osmotic blistering. Now we will consider other forms of blistering, including electroendosmosis, cathodic blistering, cathodic disbondment, and compressive stress-related blistering.

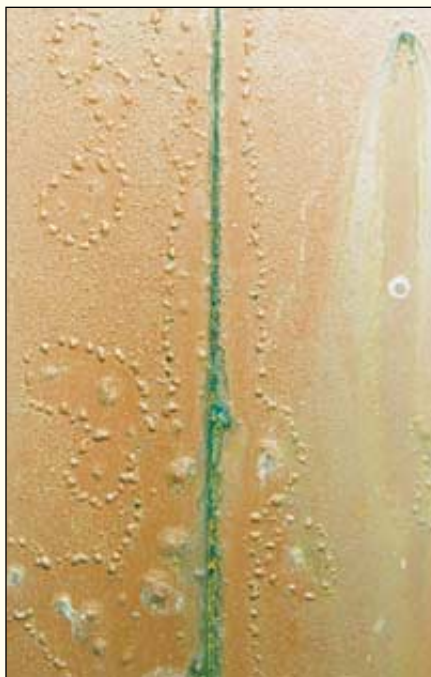
Fig. 1 - Electroendosmotic blistering around a cut scribe and discrete corroding points.

Although the phenomenon is primarily seen under electrolytic immersion (i.e., sea water immersion), it is often noted on scribed panels in salt spray testing (Fig. 1).

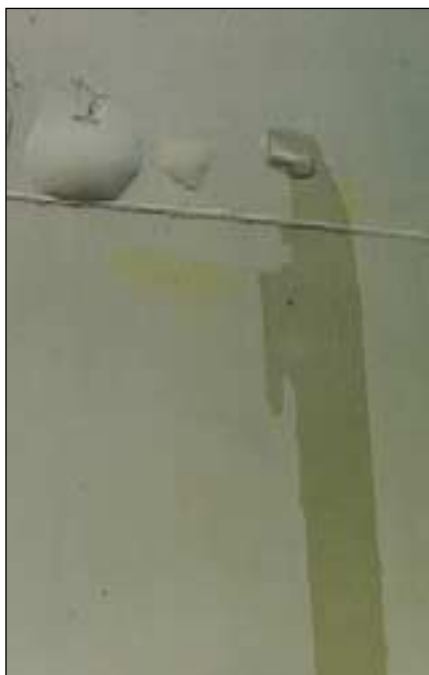
Fig. 3 - Blistering on tank exterior induced by thermal gradients. (Inside fluid was cold; outside environment was warm and humid.)

Cold wall effects may also occur on non-immersed exterior coatings of tanks containing cold water or fuel in humid environments.¹⁸ The propensity of the phenomenon to show up on storage tanks is probably related to the heat sink properties of the large body of liquid within the tank. Cold wall blisters are often very large. The author has noted large blisters 10 in. (25 cm) in diameter on the coated exterior walls of fuel storage tanks containing cold fuel in summer (Fig. 3). When these large blisters were punctured, copious amounts of water flowed out. This occurred in New York State on a dry day, following a relatively humid spell of weather. Delamination occurred at the primer/finish interface but not at the metal itself. Obviously, this interface was less secure than was that of the thin film of primer to the metal. It seems likely that osmotic effects, probably related to inhibitive pigments within the primer, also played a role in this failure. It is possible that during periods of high humidity, the film takes up water vapor, which condenses against the cold metal interface on the exterior of the tank.¹⁹ Subsequently during the heat of day, the condensed water may expand and attempt to evaporate, developing high pressures over a relatively short time on the underside of the impermeable film, which may lead to the physical expansion of the blister.

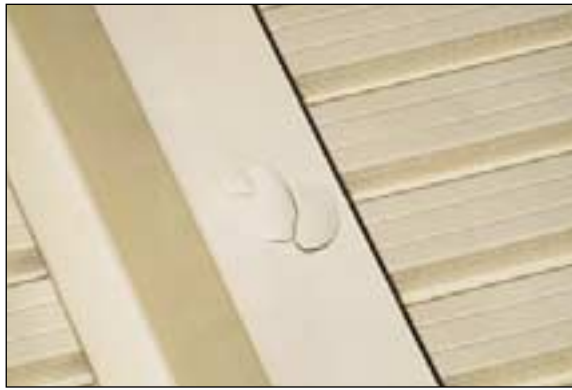
Fig. 4 - Steel exposed by thermal stress-induced blistering. (Note circular patterns relating to stepwise progression of failure.)

This type of failure looks different than other forms of blistering. Often in thermosetting systems such as epoxies, urethanes, polyesters, and older alkyds, de-adhesion generally occurs in large, irregular flakes and sheets rather than as discrete hemispherical blisters. The interiors of these stress-induced "blisters" are quite dry, and the domes are less defined. The delaminating film segments have a typical convexity towards the coating/air interface (concave to the substrate), which betrays response to compressive stress. Usually, such delaminations can be detected before any actual flaking occurs; an audible response to a tapping of the areas with a finger indicates some intra-system cavity. Failure may sometimes progress outwards from a central point of initiation, leaving a series of concentric cracks (Fig. 4).
