LIQUER TANK COATING

CONCRETE AGGREGATE FEED SCREW

CASE HISTORY #018 REV.04-97

PAPER MILL SELECTIFIER SCREEN REBUILD

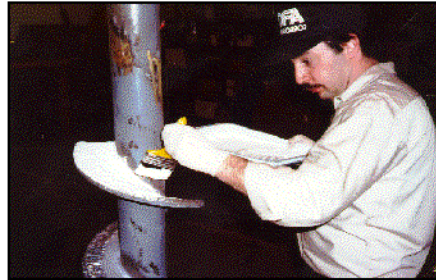
Hand-applied ARCOR™ S-16 White

Concrete aggregate feed screw veins were badly eroded from wear and needed to be rebuilt. ARCOR™ applied a primer coat of ARCOR™ S-16. This particular installation only called for two coats of protective coating. Screw veins were top coated with ARCOR™ S-20 Black, veins only. Equipment has been back in service for 5 years with no problems.

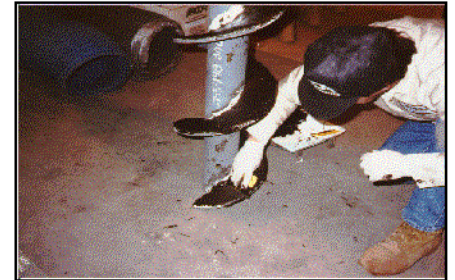
Hand-applied top coat of ARCOR™ S-20
