WATERBOX RESTORATION

CASE HISTORY #026 REV.04-97

CAST IRON INTAKE VALVE REPAIR

CAST IRON WATERBOX REPAIR

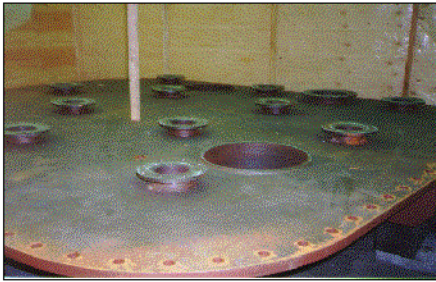
White metal-blasted waterbox cover

ARCOR™ protective coating system was installed at the manufacturer's facility. Waterbox was new and specified ARCOR™ coatings prior to being put in service. Entire waterbox was abrasive-blasted to White Metal (SSPC-10) and then primed with ARCOR™ S-30 Prime. A layer of ARCOR™ S-30 Blue was then applied as a top coat. Total protective coating system resulted in a film thickness of 40 mils.

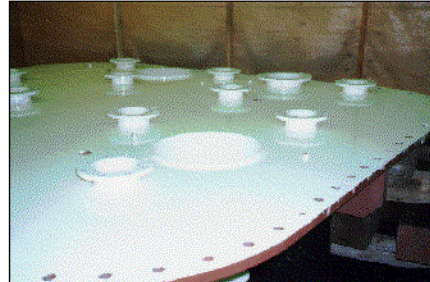
Primed with ARCOR™ S-30 Prime

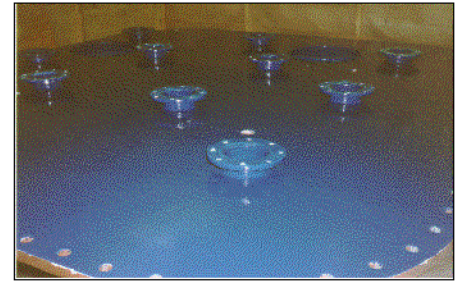
Top coat with ARCOR™ S-30

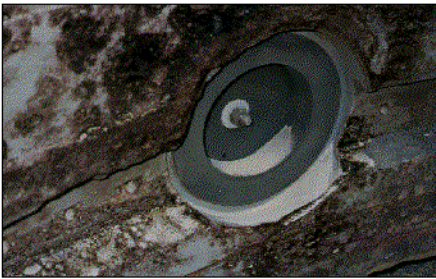
Valve body surface ready for coating

Cast iron salt water intake valve body badly eroded and corroded after years of service. Surfaces were abrasive-blasted. A base coat of ARCOR™ S-16 was installed. ARCOR™ TS-RB was then applied by squeegee to fill the voids left by the aggressive corrosion. A top coat of ARCOR™ S-16 Blue was applied by brush building the dry film thickness up to 30 mils. Coating thickness was as much as one half inch in areas of deep pits.

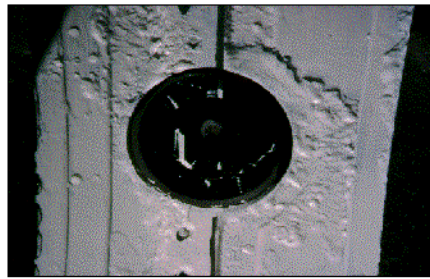
ARCOR™ S-16 Primer coat

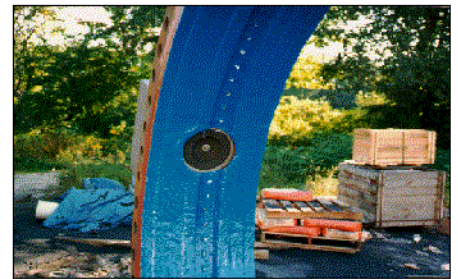
Unit with ARCOR™ S-16 Blue top coat

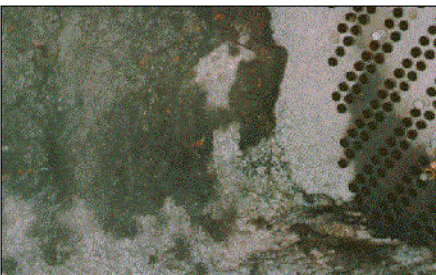
Corroded surface inside waterbox

Main condenser cast iron waterboxes were experiencing corrosion and metal loss in salt water service. Metal loss was severe adjacent to the Muntz Metal tubesheet where dissimilar metals set up a galvanic cell. A three-step coating system was installed to protect the cast iron substrate from further corrosion and erosion damage. The ARCOR™ system provides a barrier to protect the substrate from the salt water and acts as an insulator to eliminate the galvanic cell.

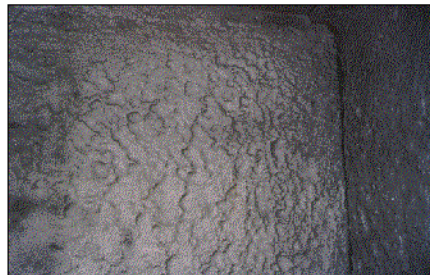
Abrasive-blasted interior

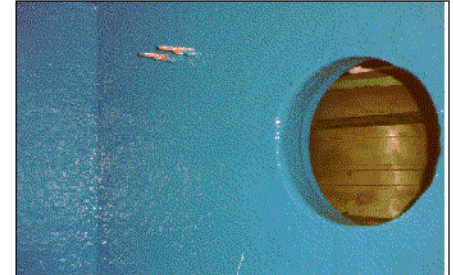
Top coat of ARCOR™ S-30 Blue
