## CHEMICAL DRAIN BASIN

CASE HISTORY #029 REV.04-97

## DEMINERALIZER FLOOR

## NEUTRALIZATION BASIN REPAIR

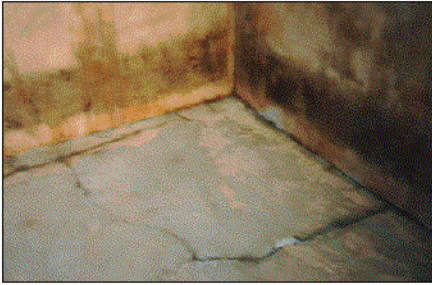
Cracks in the concrete flooring

A concrete liquid-waste drain basin, located next to a river, settled over the years, developing large cracks in the floor. High-pressure water wash was used to clean the substrate, followed by light abrasive-blasting to further clean and roughen the surface. ARCOR™ ARCRETE was applied to the floor 1-inch thick to fill the cracks and form a continuous protective lining. Two layers of chemical resistant ARCOR™ S-20 were then applied as a top coat

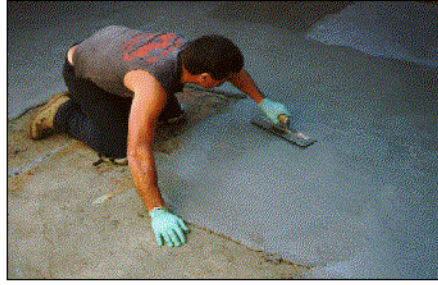
Application of ARCOR™ ARCRETE

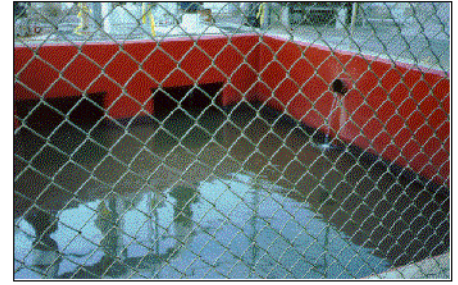
Basin repaired and in service

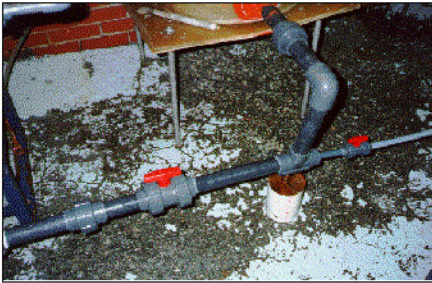
Severely damaged concrete floor

A concrete floor in a demineralizer chemical storage area was severely attacked by sulfuric acid and sodium hydroxide. The floor was high pressure washed. A layer of ARCOR™ ARCRETE was applied to severely eroded areas. Next, ARCOR™ S-20 was installed. The base coat was then thoroughly cleaned and top coated with ARCOR™ S-20. In areas where leaks were present, ceramic tiles were cemented in place with ARCOR™ TS-RB for extra protection.

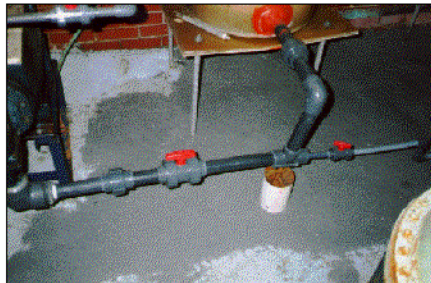
After application of ARCOR™ ARCRETE

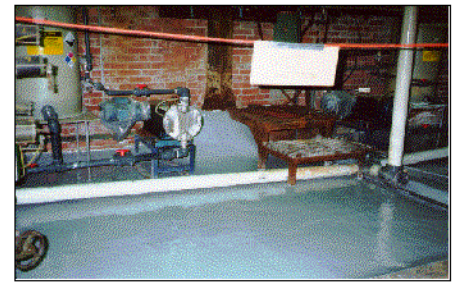
Topcoat of ARCOR™ S-20

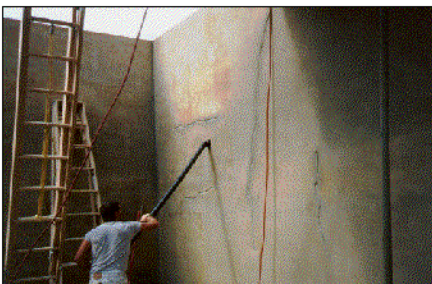
Cleaning cracked wall surface in basin

A concrete neutralization basin developed large cracks in the wall due to settling. Some of the cracks were severe enough to allow liquid to penetrate the walls. The inside of the basin was thoroughly dried and abrasive-blasted. Spent grit was carefully cleaned away from the floor and walls. ARCOR™ TS-RB was installed into crevices using a squeegee and then filled flush with the surface. Two coats of chemical resistant ARCOR™ S-20 were then applied.

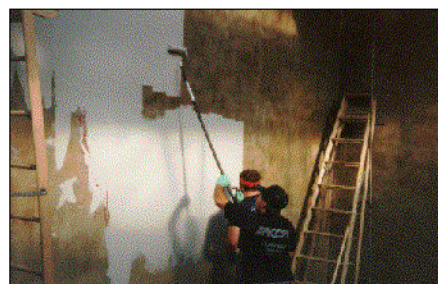
Application of ARCOR™ S-20

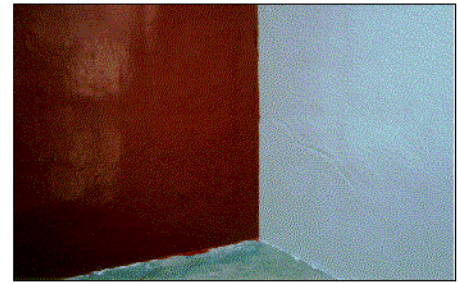
Unit completed with two coats ARCOR™ S-20
