SEWAGE EVAPORATOR TANK

CASE HISTORY #032 REV.04-97

TRANSFORMER NETWORK BOX

WATER / SEWAGE PUMP REPAIR

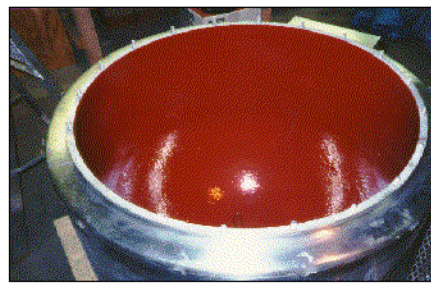
Spray Application of ARCOR™ S-20

Factory-applied Teflon coating on sewage evaporator tank field failed. ARCOR removed all old coating and prepared surface with a white-metal blast. A primer coat of ARCOR™ S-20 White was spray-applied, shortly followed by an intermediate coat of ARCOR™ S-20 Red. Installation was completed with a top coat of ARCOR™ S-20 Black to 60 mils total protective coating.

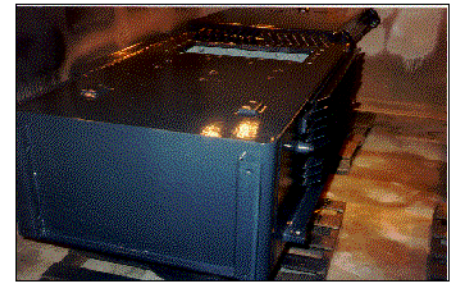
Completed with two coats ARCOR™ S-30

Underground transformers subjected to corrosion due to ground water seepage. Cracked Floor In Drain Basin. Transformer casings were sent to ARCOR's facility for coating. After plugging holes and taping threaded studs, these units were abrasive blasted. A base coat of ARCOR™ S-30 White was then applied followed by a top Application Of ARCOR™ ARCRETE

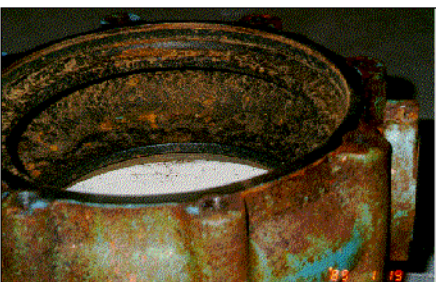
Corroded pump casing before preparation

Raw sewage and water pump experiencing corrosive attack. The entire pump casing and side plates were abrasive - blasted to clean the surface. A two-coat system of ARCOR™ S-30 was installed to insulate the substrate from the harmful effects of the liquids being pumped. This pump was lined in January 1989. The customer was pleased with a six-month trial run. A second pump was coated in early 1990.
