WATER CHILLER / CONDENSER REPAIR

CASE HISTORY #035

CARBON STEEL HYDRO PENSTOCK

WICKET GATE REPAIR

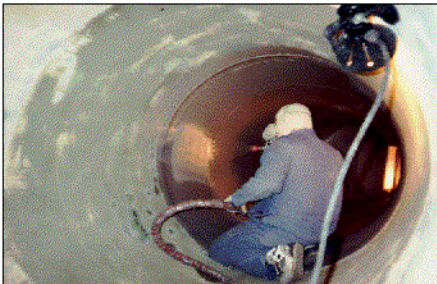
Blasting surface clean

Carbon steel, welded construction hydro penstock with a 25 0-foot head developed concentrated corrosion. The penstock was first dried thoroughly. Abrasive-blasting followed to remove the failed lining, clean the substrate to SSPC-SP5 Standards and install a 3-mil minimum anchor profile. Two coats of ARCOR™ S-30 were spray-applied at 20 mils per coat for a total DFT of 40 mils. ARCOR™ TS-RB rebuilding material was installed between coats where pitting was evident.

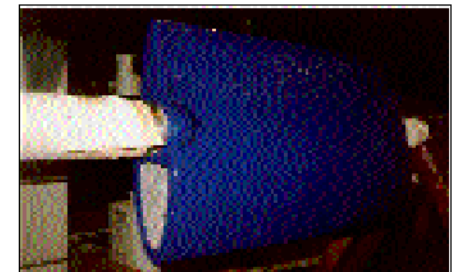
Top-coated with ARCOR™ S-30 Blue.

Cast wicket gates used to direct the water flow over a hydro runner were damaged by corrosion. After abrasive-blasting, a three-coat system of ARCOR™ S-30 was installed by hand, with ARCOR™ TS-RB rebuilding material applied between the first and second coats to replace base metal that had been eroded away. This project was completed in September 1989 and is still in service today.
