## MAIN CONDENSER COATING

CASE HISTORY #039 REV.04-97

South Ukraine Nuclear Power Plant Unit #1, Ukraine

CASE HISTORY #040 REV.04-97

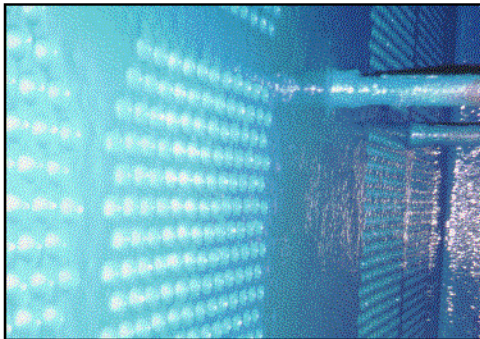
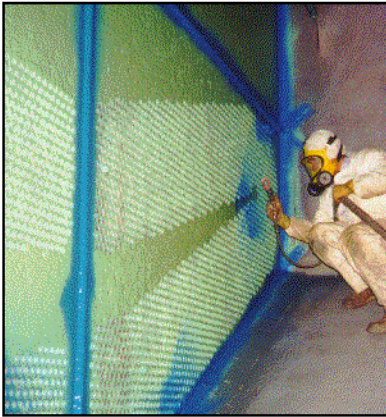
This nuclear power plant had problems with a general leaking of the condenser at the tube to tubesheet joint. Continued sever scaling of the tube internals was causing a steep decline in heat transfer.

The unit has 116,000 9 meter, 26mm ID 95/4/1 CuNiFe Tubes and 24 Carbon Steel tubesheets at 25 M2 each. All tubes were to be cleaned and all tubesheets coated.

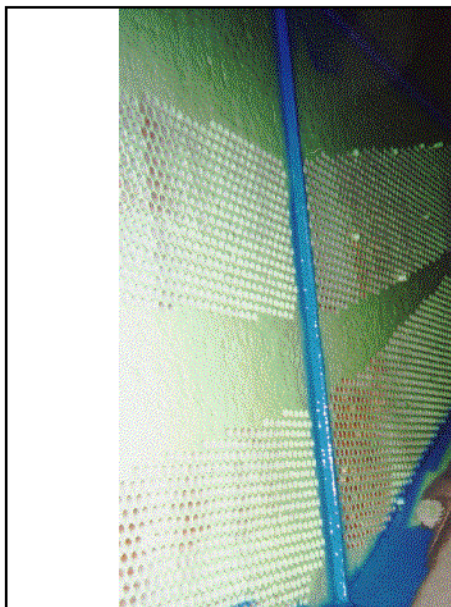
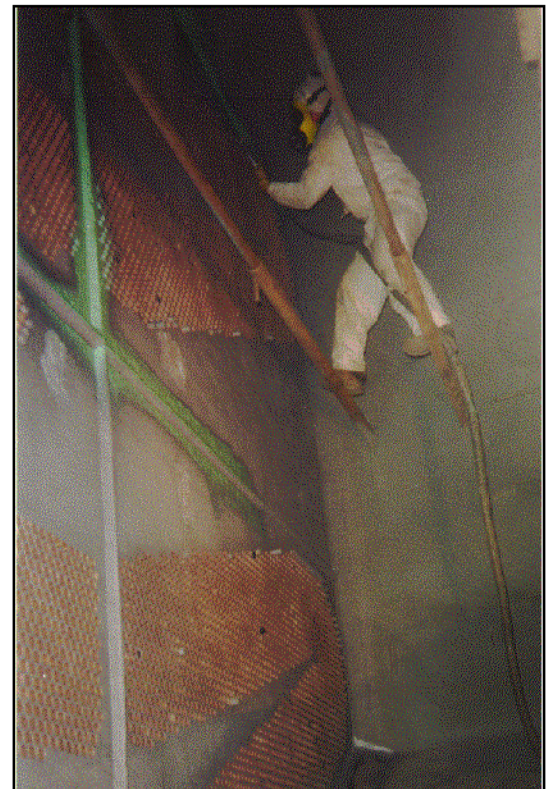
Severe scaling of the tube internals was causing a steep decline in heat transfer. All 116,000 tubes and tubesheets were cleaned and all tubesheets coated.

The tubes were cleaned using a 4 hp air powered tube cleaner with an attached 15 M rotating flexible shaft with a carbide bit and brass brush mounted on the end.

S-30 Prime and S-30 were spray applied in 2-coats to a final DFT of 50 mils without the use of coating plugs.
