## BRIDGE EXPANSION JOINT

## CASE HISTORY #046

## CLEAN ROOM FLOOR

## CONCRETE SECONDARY CONTAINMENT REBUILD

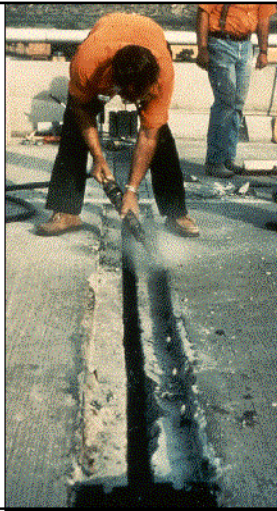
The existing expansion joint is removed by air-chisel. The area is then high-pressure power washed and neutralized from possible chlorides contamination.

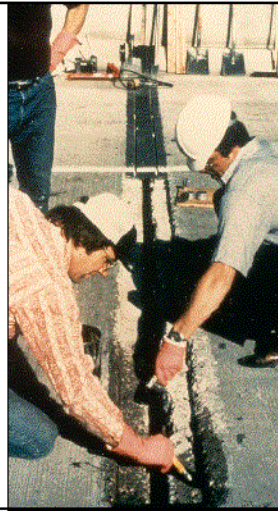
A primer coat of EE-79 is applied by brush to work into all crevices. This is allowed to cure for 2 hours. ARCTHANE is then caulked into the 90° road interface & allowed to set 2 hours.

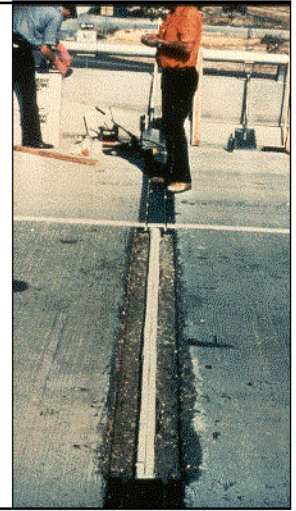
A rubber backing is installed into the expansion crevice and the remaining area is filled with ARCTHANE. The area is ready to put into service within 4 hours of final ARCTHANE install.

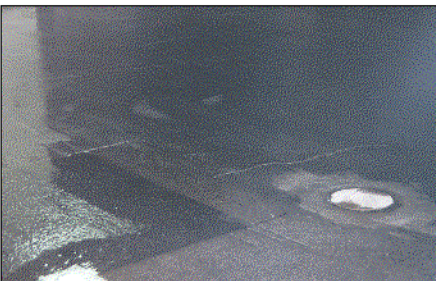
20 mils EE-79 . Area around drain rebuilt

A medical products manufacturer was installing a new clean room facility. The floor could see exposure to acids & caustics and mechanical damage from dropped tools. The customer wanted a floor to withstand the exposures and one that would be easy to keep clean, and seamless to minimize areas for contamination. The **FloorGuard™ MaxiGuard** System was used for its chemical & impact resistance. A 1st coat of EE-70 @ 20 mils; a 2nd coat of EE-71 @ 20 mils; with crack & drain repair done with ARCTHANE.

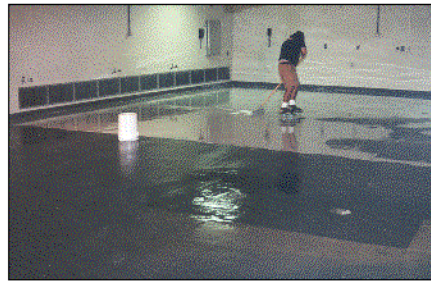
Application of 20 mils ARCORM™ EE-71

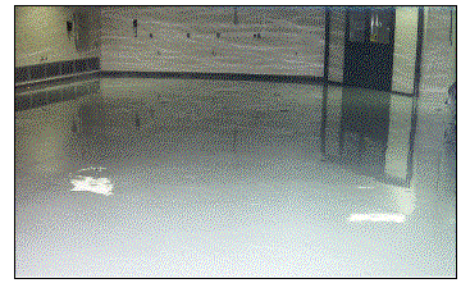
Final 40 mils.

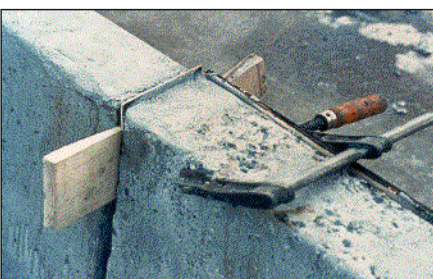
ARCRETE used with Polypropylene Form to Rebuild Damaged Walls

A Phosphoric Acid Secondary Containment area had severe concrete due to failure of a previous coating. The area was abrasive blasted with Black Beauty. Major loss areas were prime coated with EE-79. A layer of ARCRETE was then applied to level and smooth areas of concrete loss. Two 20 mil coats of EE-11 were then roller applied.

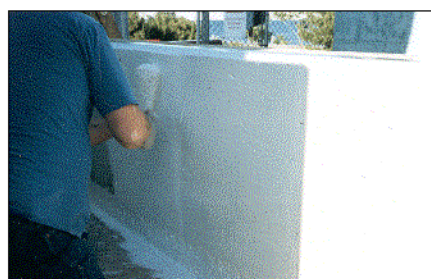
Roller Applied EE-11 Prime coat.

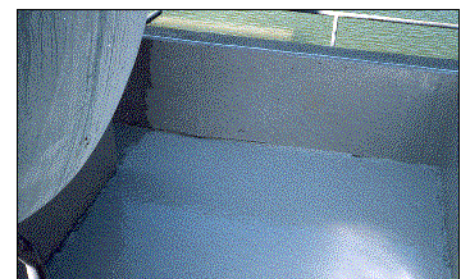
Topcoat with EE-11 for Finished DFT of 40 mils.
