CASE HISTORY – TREASURE ISLAND CASINO, LAS VEGAS

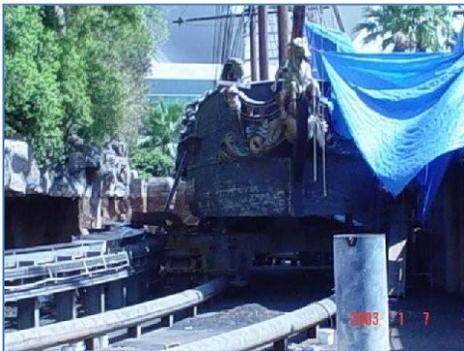
The first job coating the tracks that the ships ride on.

ARCOR’s solution, implemented in Jan. 2003, was to abrasive blast the steel track on support structures and apply a 2-coat, 16 mil systems of **ARCOR**® 1321 Black.

The **ARCOR**® 1321 was an ideal ‘single-product’ solution as its suitable for immersion and non-immersion components. Additionally, it is a high wear product able to withstand the ongoing motion of the wheels on the tracks, and it is impervious to the chemicals used to treat the water.

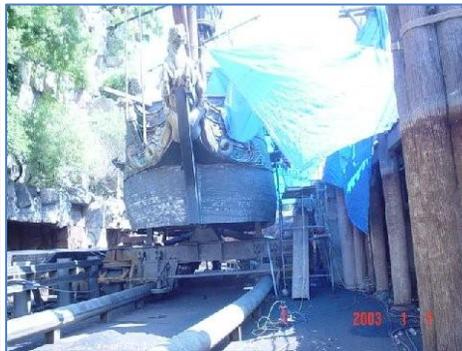
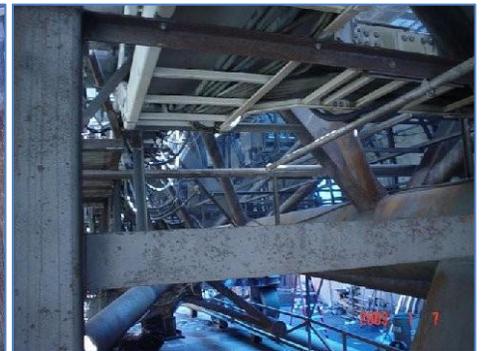
The vessels structural steel internals

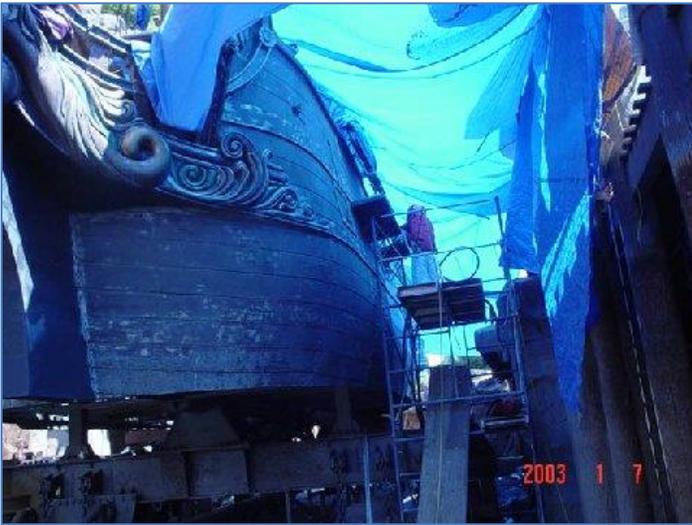
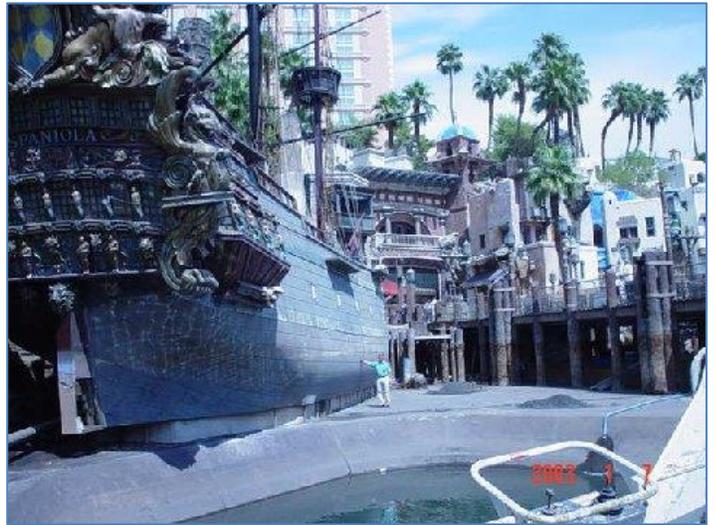
The hulls were a fiberglass composite (epoxy resin with fiberglass mat) and they had substantially degraded in the relentless Las Vegas sun, and the intense UV attack.

The resulting **ARCOR® 1321** finish was deemed too shiny (looked like a Mercedes paint job), so the design artists used various methods in spots to antique it.

ARCOR®, working with the design artists, recommended a complete sanding and cleaning the hulls.

The **ARCOR® 1321** was used with patches of fiberglass cloth to repair holes and other damage to the hulls prior to coating. The fiberglass patches were impregnated with mixed 1321 and laid over the damaged spots. Once set-up, the entire hull areas were coated with **ARCOR® 1321**, spray applied by airless sprayer.

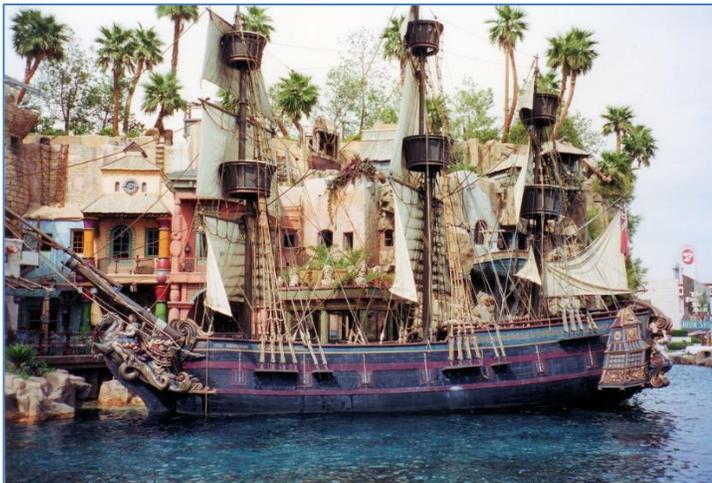
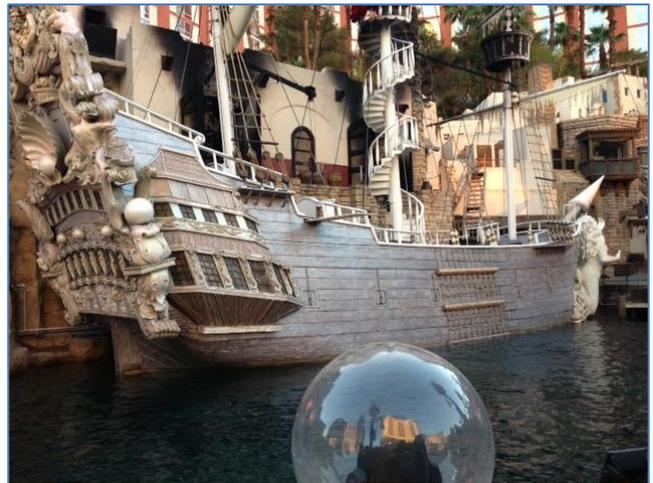
*After nearly 15 years the **ARCOR® 1321** is still resisting corrosion and UV degradation!*
