## **Microbiologically Influenced Corrosion**

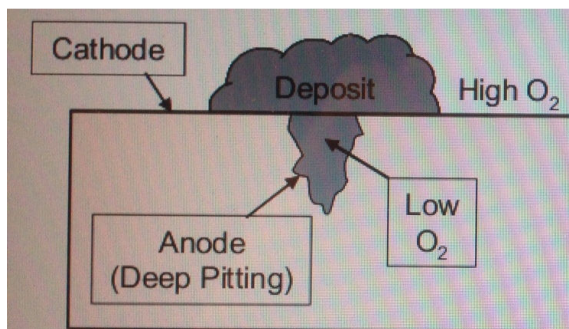
Figure 3 - Differential Aeration Cell

Differential Aeration Cell Corrosion is common in stainless steel and high nickel alloy and carbon steels. The very small amount of corrosion that occurs across the protective corrosion product film consumes (and depletes) the oxygen within the shielded area of the deposit or crevice causing that area to become anodic, while the area outside of the deposit or crevice becomes cathodic since a ready supply of oxygen

is available. Concurrently, electrochemical action within the shielded area causes the preferential dissolution of the metal resulting in positively charged metal ions. These metal ions hydrolyze, thus depleting hydroxyl ions, and the pH in the shielded area decreases. Subsequently, chloride ions from the bulk solution migrate into the shielded area to neutralize the charge imbalance which resulted from the depletion of hydroxyl ions. If the pH decreases sufficiently, and the chloride ion concentration increases sufficiently, a critical level is reached whereby the protective film breaks down and pitting is initiated. Pitting associated with this type of concentration cell is self-propagating due to the large cathode to anode ratio, and is usually rapid and catastrophic in nature.

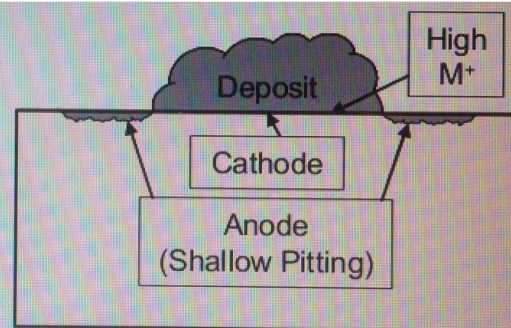
Figure 4 - Metal Ion Concentration Cell

Unlike the stainless steels, “under-deposit corrosion” or “crevice corrosion” in copper alloys proceeds via the Metal Ion Concentration Cell mechanism . With this mechanism, copper ions released by surface reactions concentrate under a deposit or within a crevice. Metals in the presence of their own ions become enobled (cathodic) and therefore the anode area develops outside of the crevice or deposit. Thus, unlike stainless steel, corrosion occurs adjacent to the deposit and tends to be shallow in nature .
